U.S. Department of Transportation

Federal Aviation Administration

Airworthiness Concern Sheet

Federal Aviation Administration (FAA) Description of Airworthiness Concern

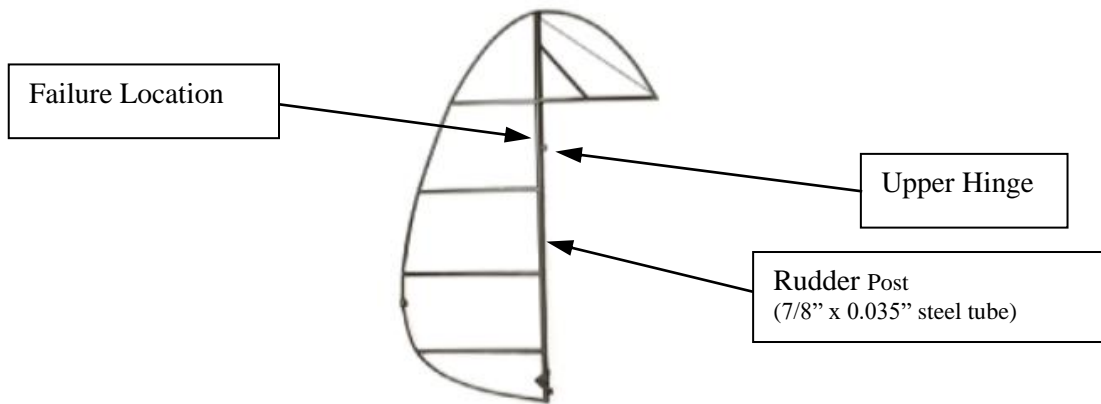
Recently an accident occurred where the rudder on a PA-12 failed in flight. The airplane was a seaplane equipped with a 160 hp Lycoming O-320 engine. The original tail surfaces had been replaced with PA-18 tail surfaces in accordance with a Supplemental Type Certificate (STC). The broken upper part of the rudder post broke just above the top hinge and the upper part of the rudder folded over the tail brace wires in such a way that rudder control was severely limited and as to effectively create an additional horizontal tail, driving the tail down and the nose up. It was possible for the senior flight instructor to control the airplane in pitch, but required a lot of the available elevator deflection to do so. By dropping the water rudders, some directional control was established and the airplane was able to return to base and land, but with difficulty.

At this time, it is not clear whether the rudder was an original Piper part, or one of the several PMA replacement parts available from aftermarket manufacturers. The accident airplane was equipped with an LED beacon on top of the rudder. The rudder had been overhauled about 6 years prior to this accident and some minor corrosion had been blended out from the exterior surface of the rudder post and the rudder had been powder coated. The inside of the rudder post was blackened, indicating the corrosion prevention oil that was applied there during original manufacture had burned off during the powder coating process. The inside of the tube exhibited some very minor corrosion pitting but was otherwise unremarkable other than evidence that corrosion prevention oil was burned off during the powder coating operation. This rudder has been submitted to the NTSB laboratory for further evaluation.

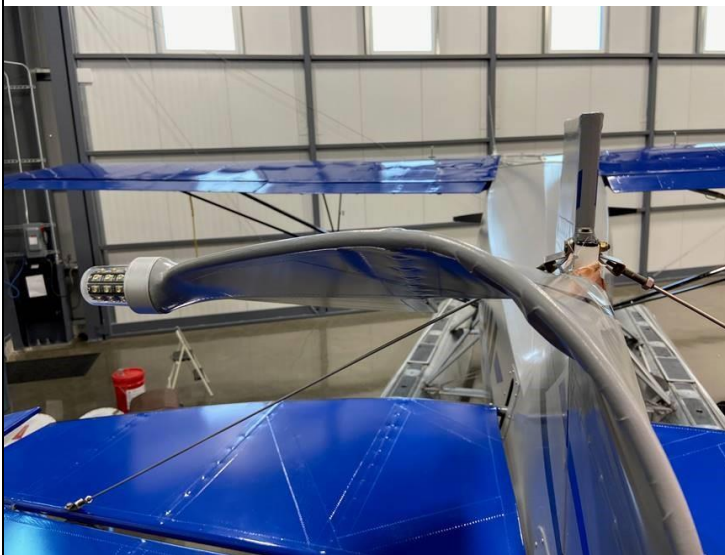
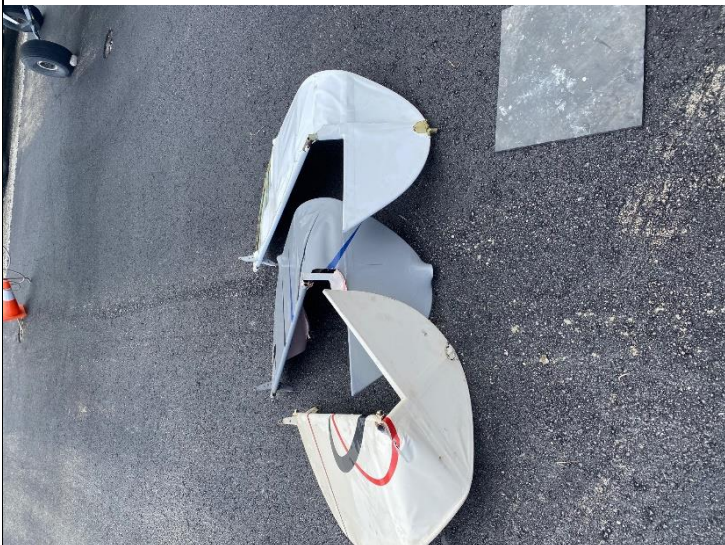
FS2003, the current type certificate holder for the PA-12 airplane, is aware of two rudder failures of the front rudder post, above top hinge, on PA-12 airplanes. One was caused by a cable strike. The other was caused by previous damage not being detected after the airplane went over on its back while operating on skis in deep snow.

At some point in the production of these series rudders, a change was made in the manufacture of these rudders to make the subject rudder post tube out of 4130 Condition N tubing as opposed to 1025 mild steel. We believe that rudders manufactured after about June 1974 will have been made out of 4130. The NTSB will be analyzing the failed rudders they have to see if they were 1025 or 4130.
