# MANDATORY SERVICE BULLETIN

Service Bulletin No. 627A (Supersedes Service Bulletin No. 627) Engineering Aspects are FAA Approved

SUBJECT: Exhaust System Inspection

MODELS AFFECTED: Lycoming Engine Model TIO-540-AJ1A

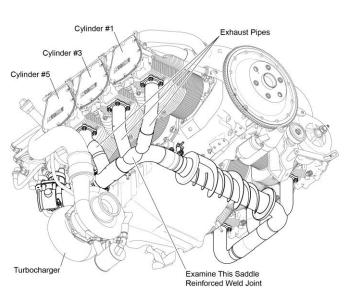
Figure 1
Installed Exhaust System
(Cylinders #1, #3, #5 - Right Side of Engine)

1. Examine the weld joints of the exhaust pipes for all cylinders (Figures 1 and 2). Closely examine the saddle reinforced weld joints (Figures 3 and 4), especially at the #3 cylinder. If any cracks or damage are found, contact Lycoming Engines' Product Support at +1 (877) 839-7878 (Toll Free) or +1 (570) 327-7222.

- 3. Complete a visual inspection on the entire exhaust system (Figures 1 and 2). If any sign of leaks, distortion, or damage is found, contact Lycoming Engines' Product Support.
- 4. Since loose flange nuts can be an indication of a potential exhaust leak, complete a torque check on exhaust system flange nuts for all six cylinders. On the attached form, record the fractional amount each flange nut turns to achieve the required 96 in.-lb (11 Nm) torque. If any flange nuts are loose enough to allow movement of the washer, contact Lycoming Engines' Product Support.
- 5. Submit the completed form after each inspection to Lycoming Engines either online or by mail.

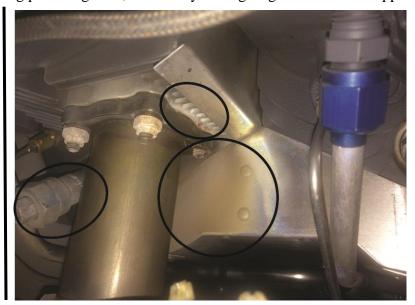
Figure 5
Signs of Exhaust Leak

2. Examine all cylinder exhaust flanges (Figure 5) for damage, distortion, or signs of exhaust gas leaking past the gasket, especially at the #2 cylinder. Indications of a flange gasket leak are burnt paint around the exhaust flange bosses or powdery white to light brown or black residue near the leaks, on the spark plug, and the baffle. If the flange or pipe is distorted, damaged, or there are signs of exhaust leaking past the gasket, contact Lycoming Engines' Product Support.
