SPECIAL CERTIFICATION REVIEW

Eclipse Aviation Corporation Model EA500 Airplane

September 12, 2008

*Prepared for the Federal Aviation Administration
Associate Administrator for Aviation Safety*

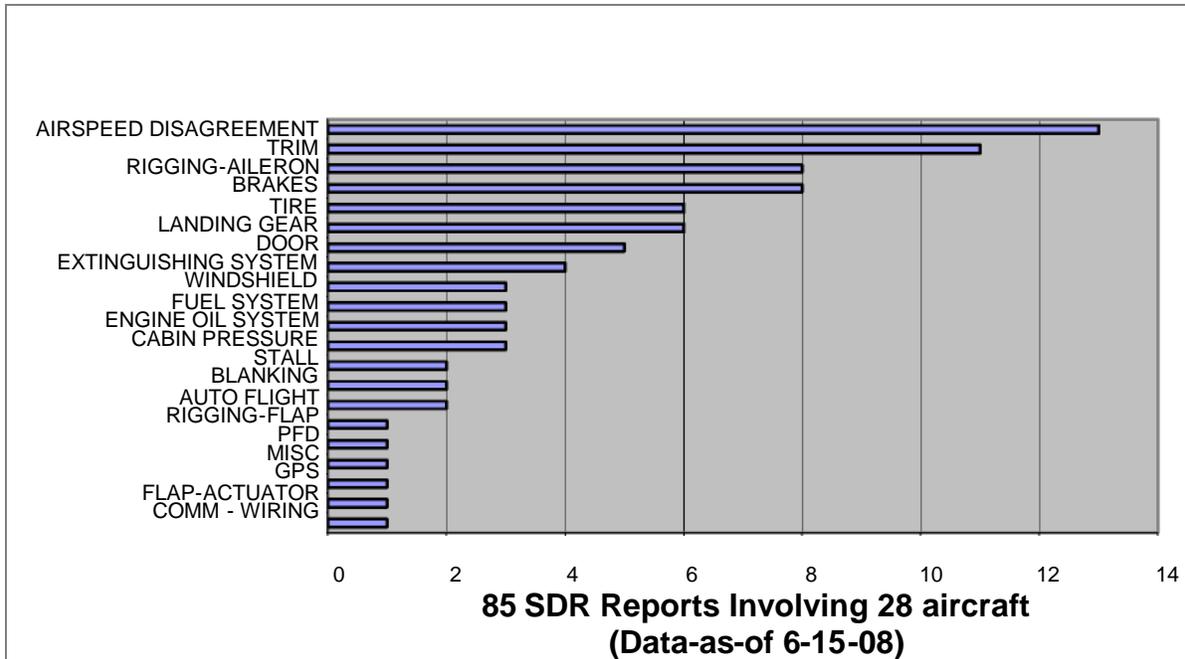
Figure 4—Eclipse 500 SDR Classification

The SDR data was classified into general categories to help identify trends and records pertinent to the SCR Team's four focus areas. The 85 events were classified into 21 categories, which are shown in figure 4. Of these categories, the highest number of reports (13 reports) involved "airspeed disagree" messages displayed on the PFD, with the next highest report count (11 reports) related to the airplane's trim systems. It should be noted that these categories should not be considered definitive because some of the categories are interrelated. For example, an aileron rigging issue could manifest itself as a trim issue or vice versa.
