SERVICE BULLETIN

Beechcraft

TITLE: FUEL - INSPECTION FOR CHAFING OF ELECTRICAL CONNECTOR AND ASSOCIATED WIRING ON FUEL LINE

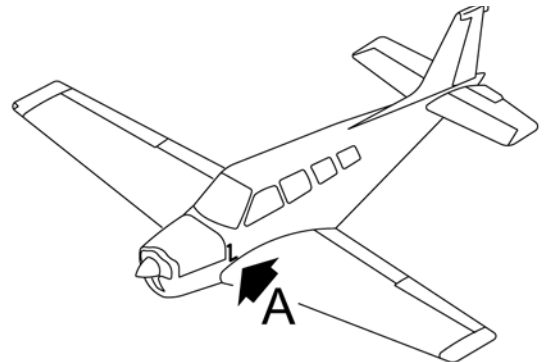
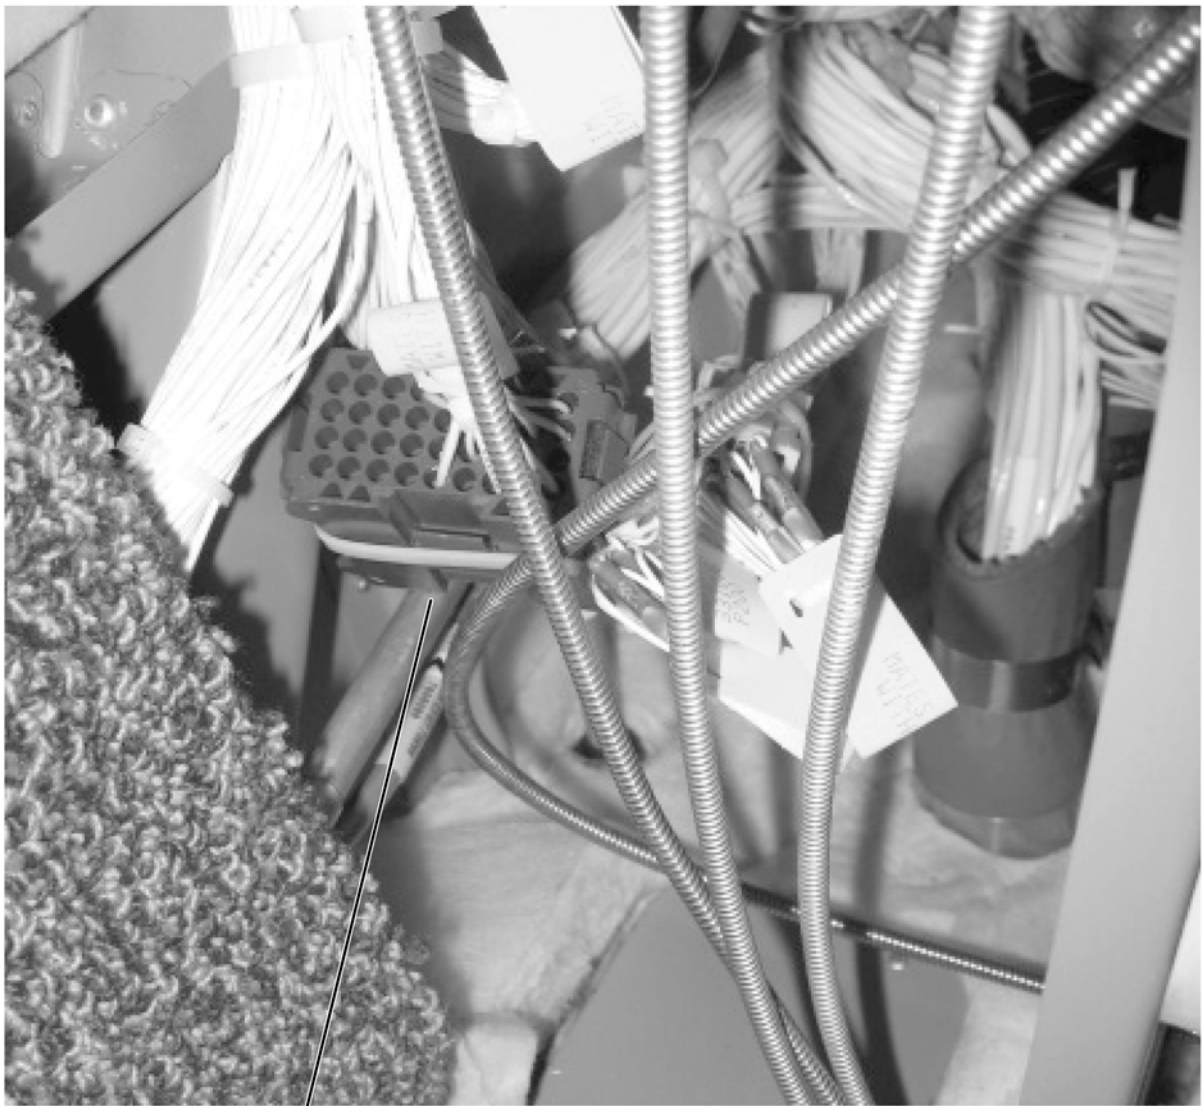
View Looking Up and Outboard from Above Pilot's Rudder Pedals
Figure 1

This Service Bulletin is being issued to inspect for and, if found, correct an improper installation of the P60 / J60 electrical connector, associated wiring, and fuel line. Contact between the fuel line and electrical components may cause damage to the fuel line, up to and including leakage. Safety Communiqué 303 was issued on this subject in April of 2009.

AREA OF POTENTIAL CHAFING

IF:	THEN:
The fuel line, connector or associated wiring is damaged.	Replace fuel line if damaged. Replace or repair damaged wiring (Refer to AC 43-13-1B, Chapter 11). Replace connector if damaged. Ensure fuel line, electrical connectors and associated wiring are secure and have a minimum of 0.50-inch separation.
The fuel line has factory protective insulating tube properly installed (starting at the firewall and continuing for a minimum of 10.50 inches past the first bend in the fuel line). Refer to Figure 2. No damage to the fuel line, electrical connector or associated wiring.	Ensure fuel line, electrical connectors, and associated wiring are secure and have a minimum of 0.50-inch separation.
The fuel line does <u>not</u> have factory protective insulating tube properly installed and there is no damage to the fuel line, electrical connector, or associated wiring.	Install spiral wrap P/N HT1/2T on the fuel line in the location depicted in Figure 2. Ensure fuel line, electrical connectors, and associated wiring are secure and have a minimum of 0.5-inch separation. NOTE If fuel line is already protected with approved chafe protection, it is not necessary to add spiral wrap.

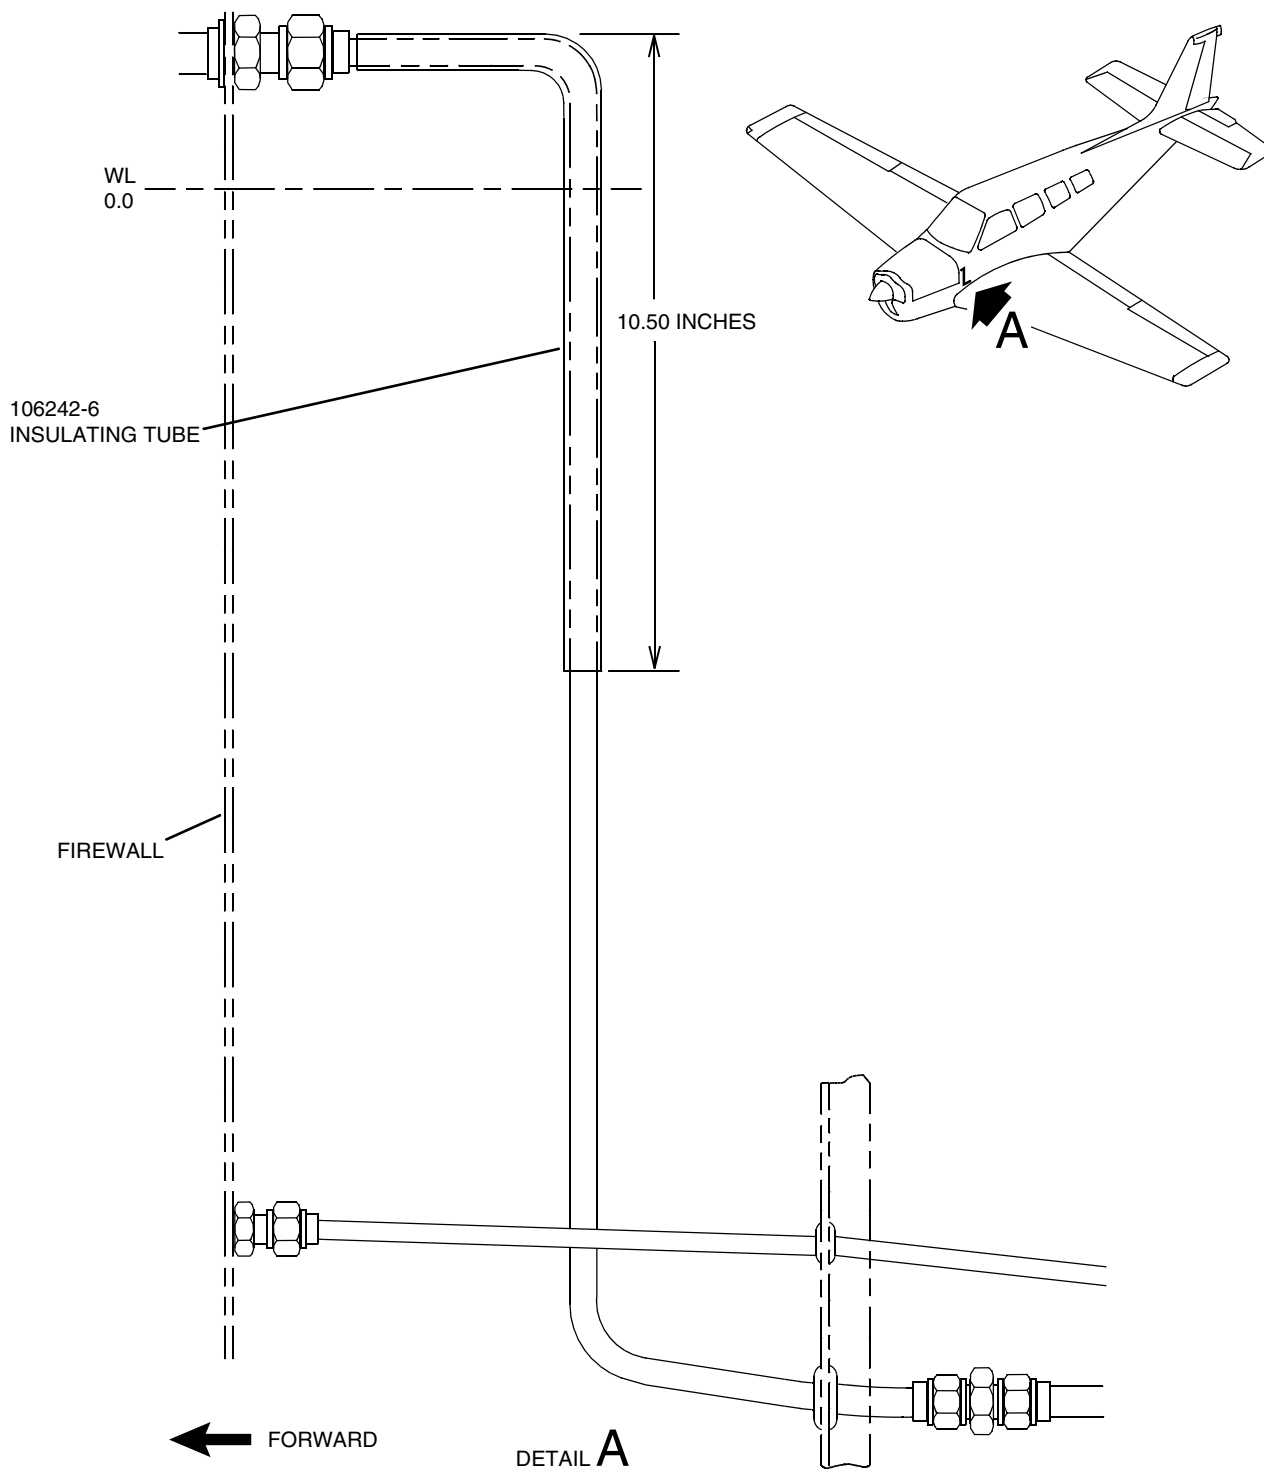
**Fuel Line with Insulation Tube Installed During the Manufacturing Process
Figure 2**
