## National Transportation Safety Board Aviation Accident Preliminary Report

<b>Location:</b>	Englewood, CO	<b>Accident Number:</b>	CEN21FA215
<b>Date &amp; Time:</b>	May 12, 2021, 10:23 Local	<b>Registration:</b>	N280KL (A1); N416DJ (A2)
<b>Aircraft:</b>	Swearingen SA226TC (A1); CIRRUS DESIGN CORP SR22 (A2)	<b>Injuries:</b>	1 None (A1); 2 None (A2)
<b>Flight Conducted Under:</b>	Part 91: General aviation - Positioning (A1); Part 91: General aviation - Personal (A2)

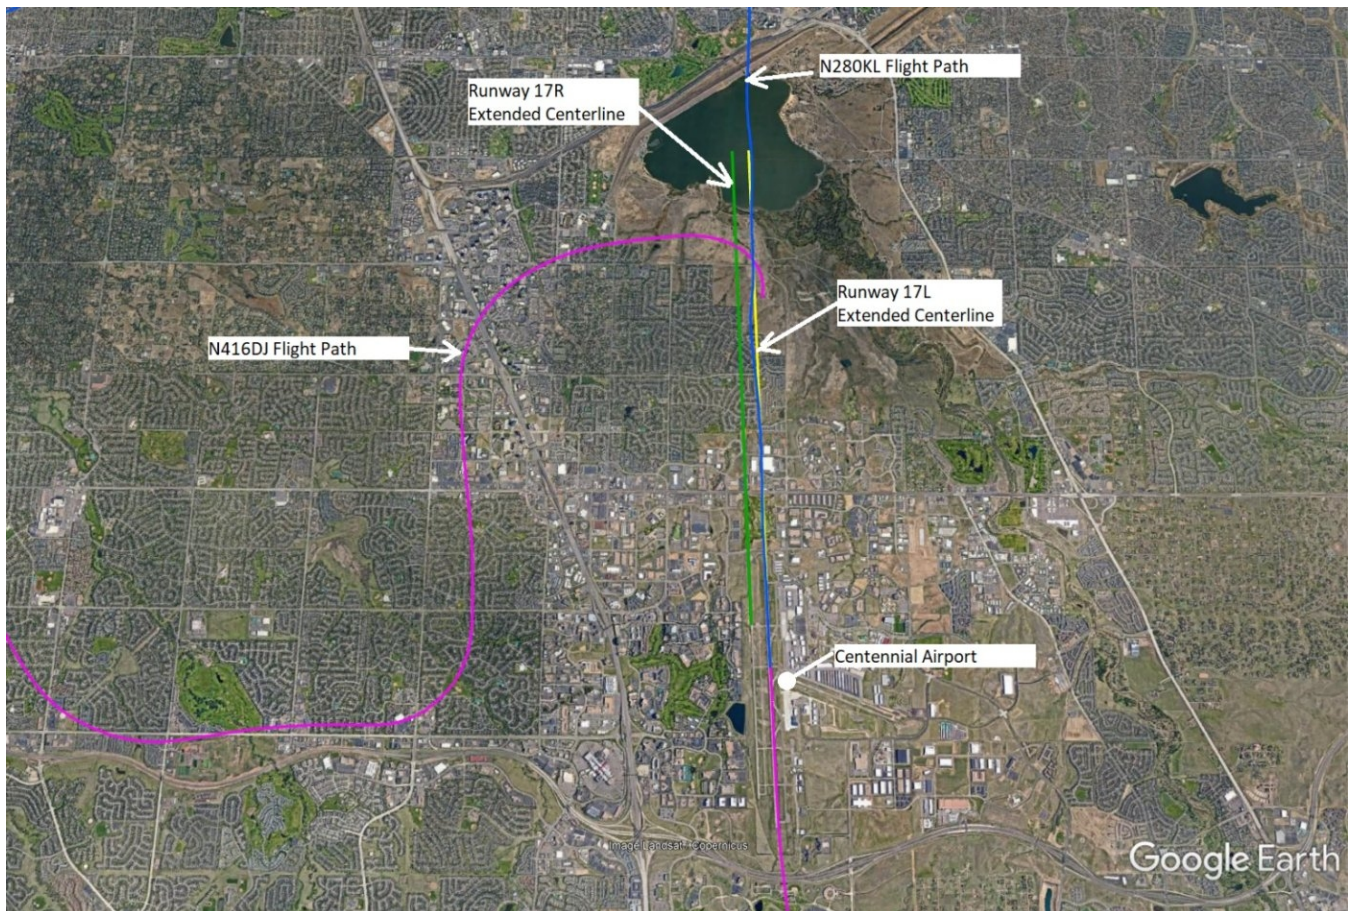
Figure 1 – Plot of ADS-B flight path information

About 1022:43, N280KL was about 5.5 nm from APA and had completed a right turn to align with the final approach course to runway 17L. At this same time, N416DJ was on the downwind leg of the right-hand traffic pattern for runway 17R just before he commenced a right turn to the base leg of the traffic pattern. N280KL continued its approach and remained aligned with runway 17L. N416DJ continued the right-hand traffic pattern through the base leg, and then began to turn toward the final approach course for the runway as depicted in Figure 1. The airplanes collided at 1023:53 when they were about 3.2 nm from APA. N280KL was aligned with runway 17L while N416DJ was turning from base to final and heading about 146° when the collision occurred.

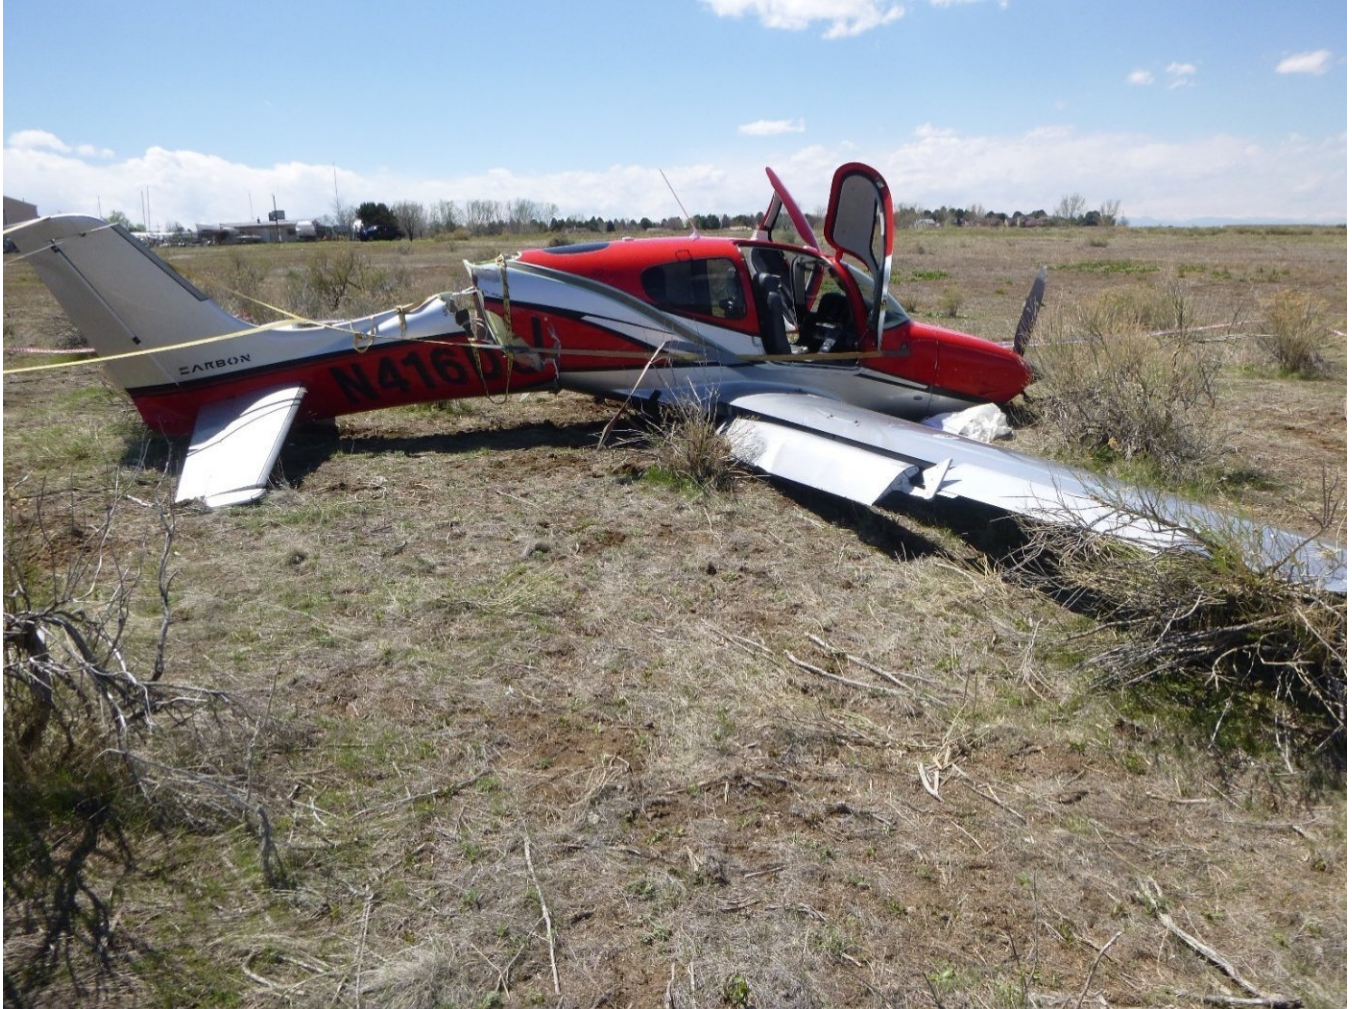
After the impact, N280KL declared an emergency, continued to APA, and landed successfully on runway 17L without further incident. The pilot of N416DL reported that the airplane was not controllable after the impact and he deployed the Cirrus Airframe Parachute System (CAPS). N416DJ came to rest about 3 nm north of APA.

Both airplanes were substantially damaged as depicted in figures 2 and 3.

Figure 2 – Photograph of N416DJ at accident scene.

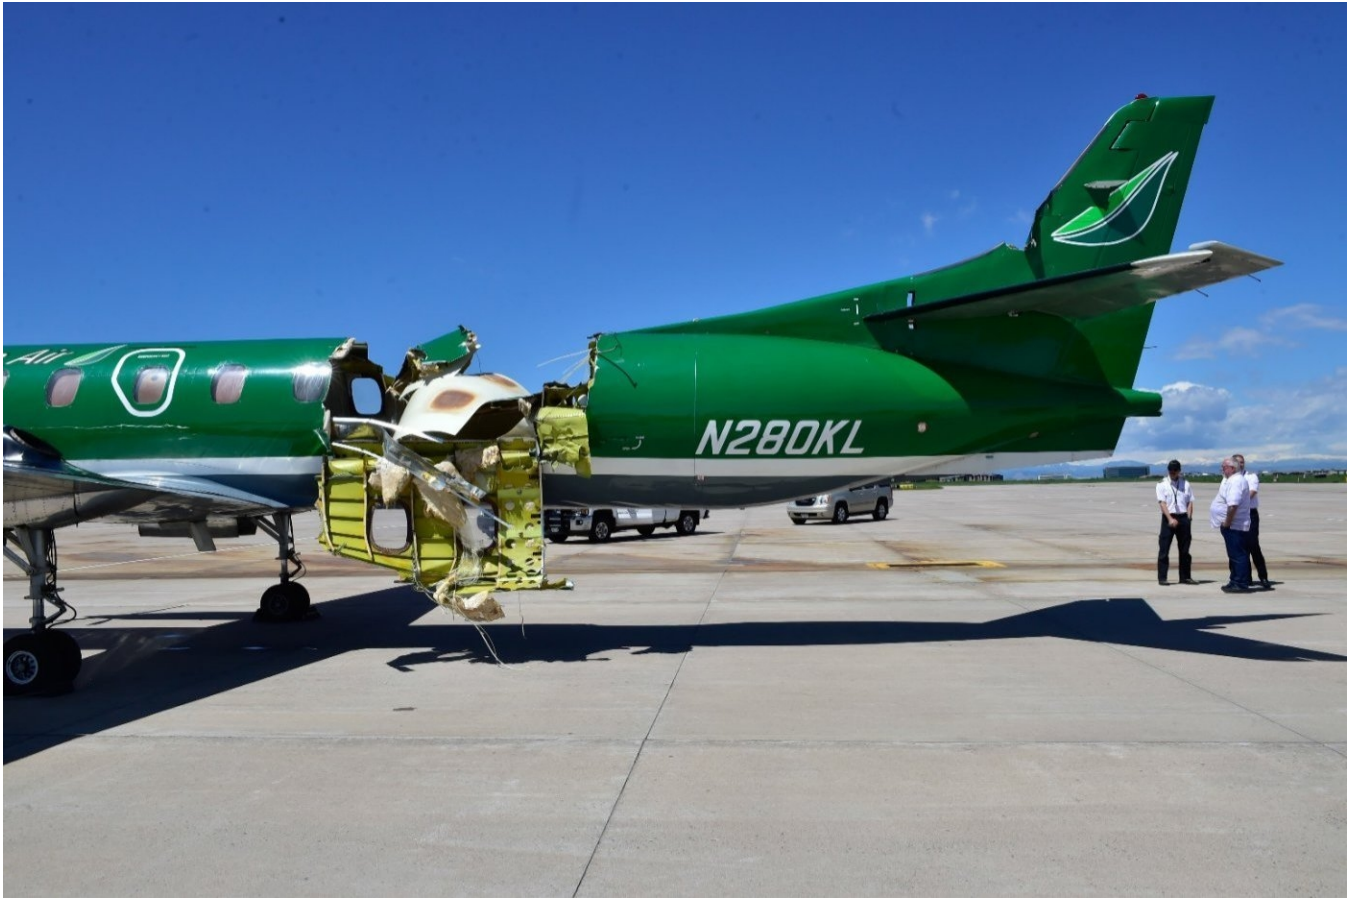
Figure 3 – Photograph of N280KL after the accident.
