**Piper Aircraft, Inc.**  
 2926 Piper Drive  
 Vero Beach, FL, U.S.A. 32960

# SERVICE NO. 1375B BULLETIN

Date: February 21, 2023

**SUBJECT:** PERIODIC REPLACEMENT OF MAIN LANDING GEAR ATTACHMENT HARDWARE

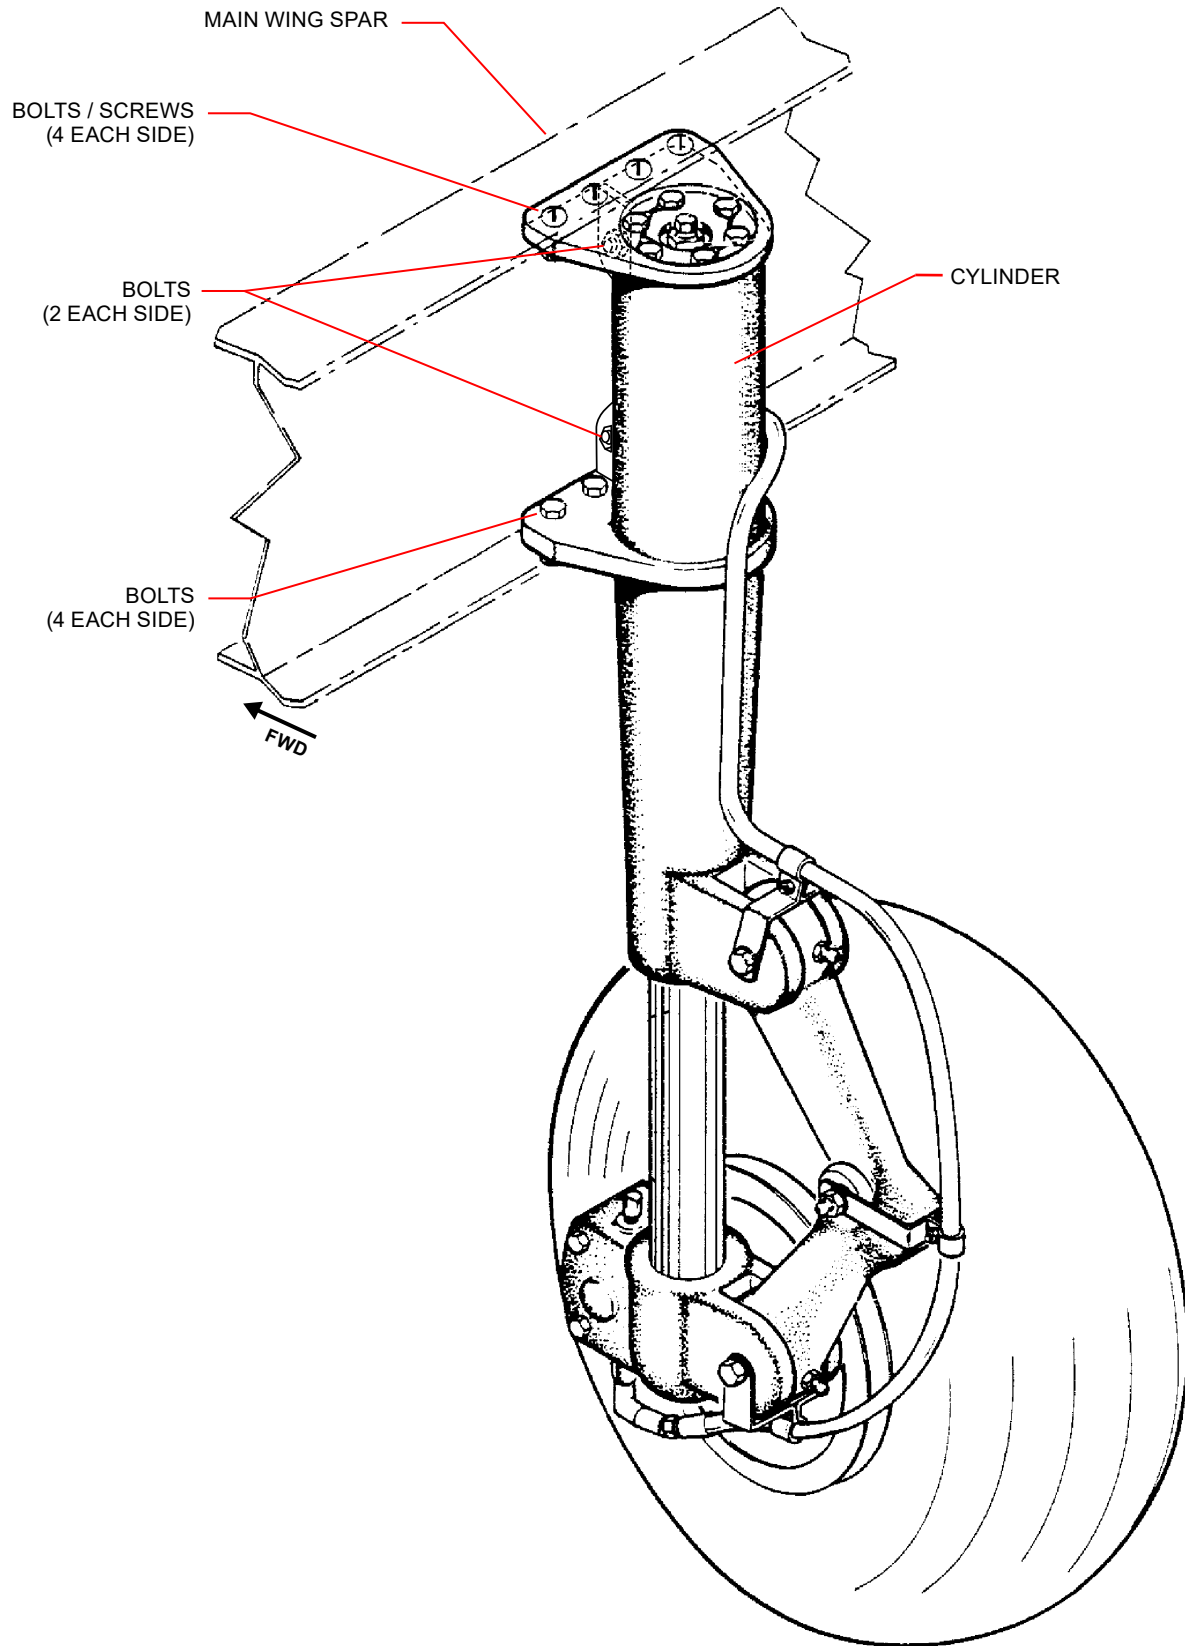
**Figure 1**  
Main Landing Gear – Mounting Hardware

A review of service history reveals that for the affected aircraft, the landing gear mounting hardware is subject to metal fatigue, hole wear and corrosion. Failure of this hardware could result in a landing gear collapse. Hole wear may cause fretting fatigue cracking.

The main landing gear (MLG) are attached to the aircraft with threaded fasteners that pass through mounting flanges on the strut cylinder and the upper and lower flanges of the main wing spar, as depicted in the illustration below. On some of the affected aircraft, additional threaded fasteners pass through the web of the main wing spar.

1. Place the aircraft on jacks.
2. Remove the fairing from around the strut cylinder housing and the access plate located on the bottom of the wing and to the rear of the housing by removing attaching screws.
3. Remove the MLG and discard all of the threaded fastener stack ups (which includes screws, bolts, nuts, and washers) that attach the MLG to the main wing spar. (See Figure 1.)
